On the Probable Technical Reasons of the Devastating Flood in 2015 in Tbilisi

The analysis of the possible technical reasons, which contributed catastrophic results of the flood on the Vere river 13.06.2015, which can become basis for the preventive actions in the case of repeating a similar extreme phenomenon in the future is carried out.

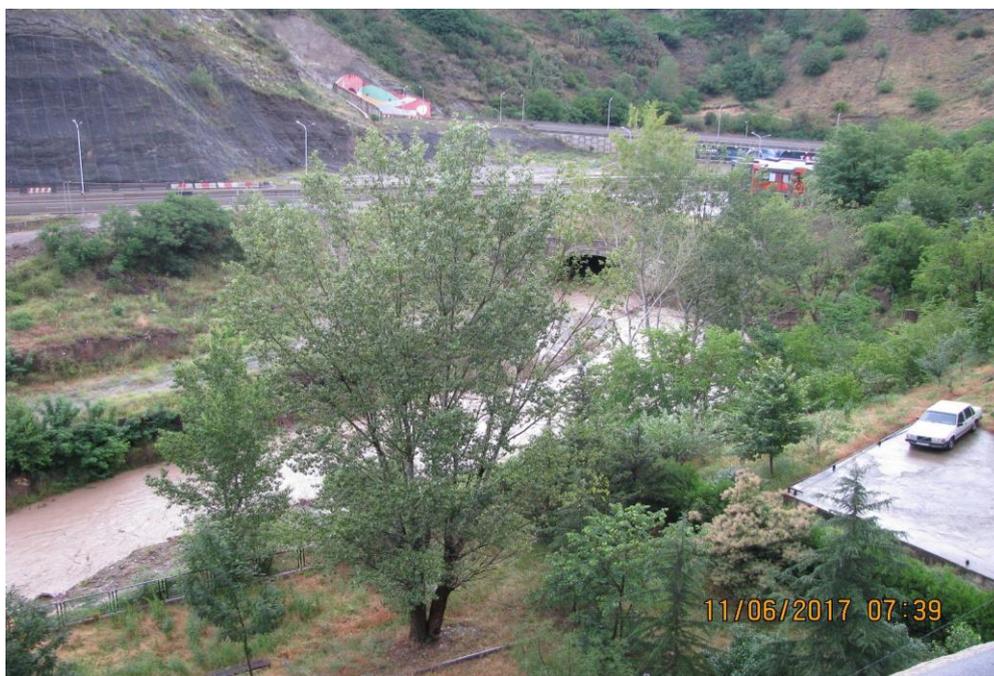
Photo 1.

Thus, it becomes obvious that the initial flood in the lower part of the Vere gorge occurred before inlet of the first tunnel. Then, regardless of the rapidly formed reservoir along the Svanidze Street, the areas in front of other tunnels were apparently also flooding. For example, after the first tunnel such a place could be the inlet of the second tunnel, or the inlet of the longest, the last tunnel connecting the Vere to the main river Mtkvari. Probably, it was the joint action of all local flood zones that resulted in heavy flooding. However, regarding the probability of possible repetition of severe meteorological conditions in the future, it seems that the discussion of the technical causes of the devastating 13.06.2015 flood should be supplemented with the fact that the river Vere has a sharp bend in front of the second tunnel (Photo 1).

Therefore, it can be assumed that together with the negative effect of the hydraulic resistance of the tunnel, this place inevitably became one of the initial flood areas during the devastating flood. In the process of reconstruction of the closed channel, it was evidently noticed. Therefore, seemingly, to avoid danger in the future, guiding walls were placed in front of the inlet of the second tunnel. Photo 2 shows that this additional structure resembles a funnel, the purpose of which, according to the plan, is to direct the water flow towards the tunnel. The first segments of these guide walls are parallel to the tunnel. The other segments, having a length of about 5 m, form following angles with the axis of the tunnel: $\gamma \approx 20^\circ$ and $\delta \approx 30^\circ$. However, contrary to the assumption of the designer, who completed this upgrade, we believe that this design, under severe conditions, will only cause reduction in the water flow in the tunnel. The fact is that the guiding walls, located at such angles, will definitely create counter flows that will collide near the inlet of this tunnel. The intensity of the colliding flows will increase in proportion to the increase in the water level. A direct confirmation of this conclusion is *Photo 3*, which enables to estimate the degree of filling of the second tunnel during a fairly intense rain on 07.07.2017. On this day, the precipitation level was about 20 mm, i. e. not more than 20% of the precipitation that fell during the devastating flooding on 13.06.2015. This fact is quite noteworthy and certainly ought to be taken into account. Therefore, below we give a concise form of an explanation of the physical essence of the phenomenon, the emergence of which is obviously the result of an insufficiently thought-out technical solution.

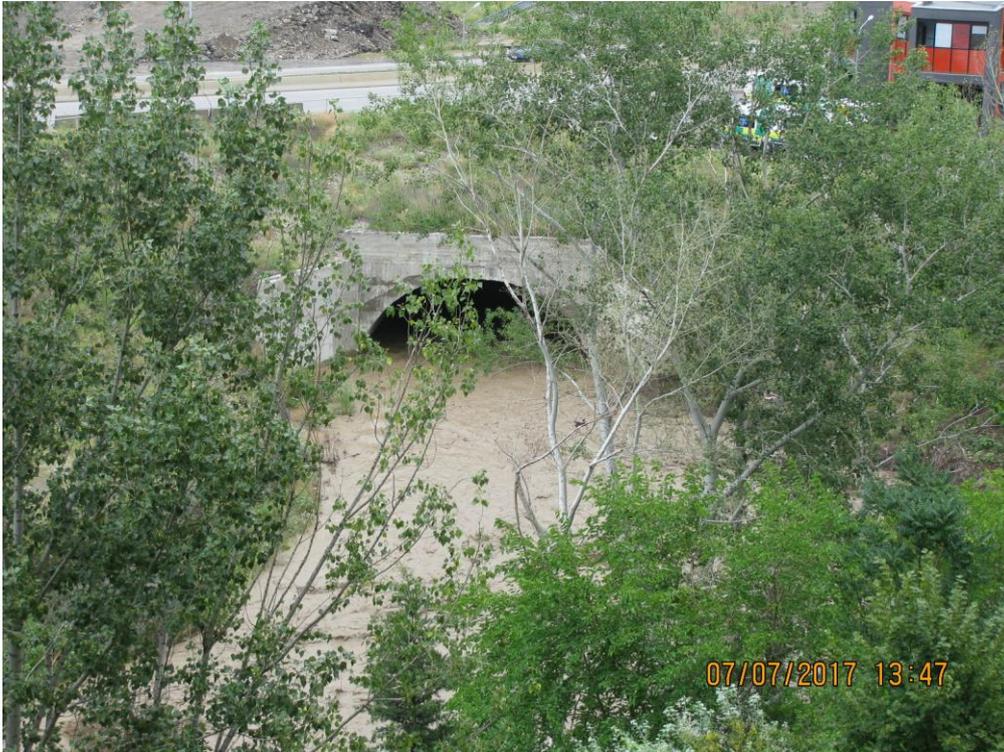
Photo 3

lead to heavy flooding between the first and second tunnels. In particular, according to the estimates made on the basis of the topographic parameters of the Vere gorge, the volume of the rapidly formed reservoir in the indicated place on the night of 13.06.2015 was $\approx 1.6 \cdot 10^5 \text{m}^3$.
